**DEPARTMENT OF TRANSPORTATION**

Contract #: 04-0120F4Cty: SF/ALA Rte: 80 PM: 13.2/13.9File #: 99.28**WELDING INSPECTION REPORT****Resident Engineer:** Casey, William**Address:** 333 Burma Road**City:** Oakland, CA 94607**Report No:** WIR-027180**Date Inspected:** 10-Feb-2012**Project Name:** SAS Superstructure**Prime Contractor:** American Bridge/Fluor Enterprises, a JV**Contractor:** L&M Industrial Fabricators**OSM Arrival Time:** 700**OSM Departure Time:** 1530**Location:** Tangent, OR**CWI Name:** Thomas Dreyer**CWI Present:** Yes No**Inspected CWI report:** Yes No N/A**Rod Oven in Use:** Yes No N/A**Electrode to specification:** Yes No N/A**Weld Procedures Followed:** Yes No N/A**Qualified Welders:** Yes No N/A**Verified Joint Fit-up:** Yes No N/A**Approved Drawings:** Yes No N/A**Approved WPS:** Yes No N/A**Delayed / Cancelled:** Yes No N/A**Bridge No:** 34-0006**Component:** CCO 196 and 203**Summary of Items Observed:**

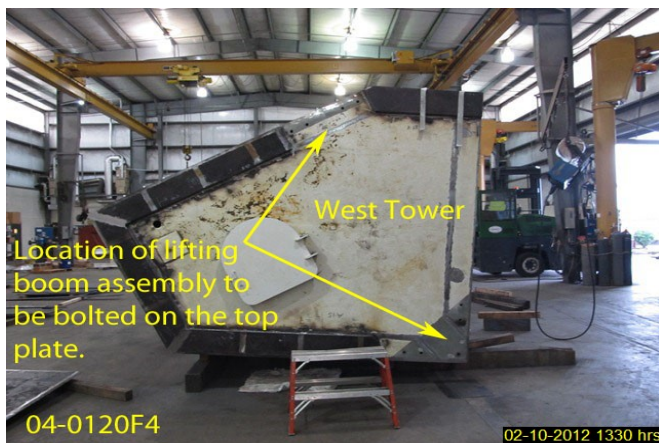
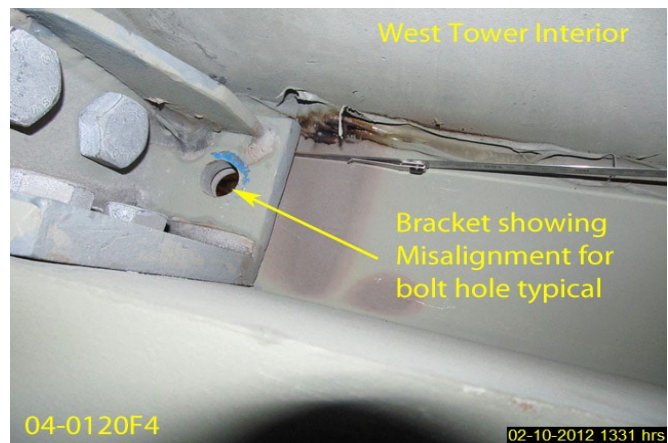
1) The bolt holes for the crane assembly to bolt to the top plate has miss-aligned holes preventing the bolts to penetrate the top plate and underside brackets. This QAI observed that the miss-alignment appeared to be approximately 5mm.

2) During the observation on the interior where the top plate and bracket meet the faying surface is not in contact and it appears that since the bracket is already bolted at 2 points (4 bolts) the faying surface would not be able to come into contact as required by contract documents. The gap was measured by this QAI inspector as being 5mm to 8mm.

This QA Inspector randomly observed that L & M personnel have halted work on this Change Order due to the layout being in the wrong locations for the brackets and that the dimension had been taken from the bottom hole located at 1731mm instead of the top at 1419mm. This has caused the layout to be off by 312mm, there 4 additional holes at each location for the external and internal brackets (total of 8 holes). These are located on skin D (4) and the internal stiffener (4). Also noted is at the top location for the elevator brackets to be installed there is an internal channel preventing the fit up at this location. The fabricator's QC Inspector Tom Dreyer has contacted the contractor ABF who is sending a Request For Information (RFI) to the Caltrans Engineer for resolution to both of these issues.

The fabricator's QC inspector Tom Dreyer has contacted his client for a RFI and is waiting for a response.
